**Flood Control Project Maintenance  
Levee Inspections**

**Maintenance Issue Types Only, Levee Inspection Report By Mile - Spring 2020**

**Sutter Maintenance Yard Maintenance Area 0013**

Waterway	Bank	Unit Miles	Inspection Start/End	Inspector
Unit No. 01 Cherokee Canal	Right	18.19	04/09/2020 04/09/2020	Makar Sokol

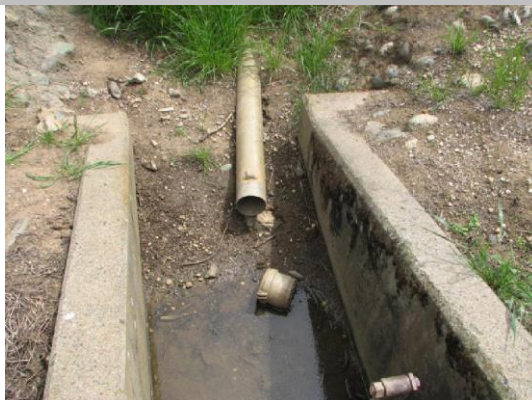
Photo 3 of 3 : UCIP\_SP\_2020\_54938\_66687.jpg

View of WS with pipe in channel.

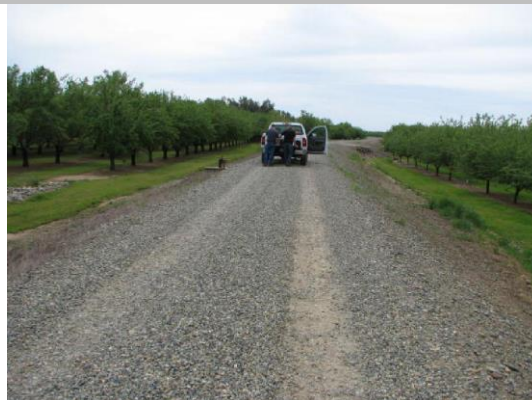
Photo 1 of 3 : UCIP\_SP\_2020\_54939\_66695.jpg

DS\_ID:16831  
FS\_ID:54939  
EP\_NO: N/A  
Repair Type: Non-Urgent  
Crossing Status: Found  
UCIP Comments: 08/06/2019 Record remains Non-Urgent, need to clarify owner for this crossing. This pipe has been identified as an LMA responsible drainage pipe. However, adjacent property owner has modified the WS outlet by burying the concrete headwall. No permit has been found authorizing the modification to the WS. LMA and adjacent property owner will need to coordinate with the CVFPB to comply with Title 23. (O. Magana - DWR UCIP, A. Freitag - DWR Sutter Yard)08/23/2018 Same as last inspection; still no sign of WS pipe end. Unclear if this SD crossing is still in use. The WS toe has standing, mucky, water around where the pipe end should be. Downgrading to Non-Urgent from Urgent because there appears no immediate threat to levee. Recommend follow up with owner to determine pipe use, and an internal pipe inspection to determine pipe integrity and threat to levee (D. Sanoski - DWR UCIP).06/14/2017 Still no sign of WS pipe end. Pipe may need to be traced with GPR and excavated to determine if the WS end was properly capped after the Headwall and pipe sections were removed. Pipe has been selected to be internally cleaned and inspected as part of the DMP project. (DWR Sutter Yard- A.Freitag)11/16/2016 WS structures still removed. (DWR Sutter Yard- A.Freitag)10/17/2016 Landowner removed WS concrete headwall and pipe section through floodway to make room for orchard. The area disturbed appears to be from WS toe to where the mature trees are located within floodway, approximately 45 feet from WS toe. Crossing is classified as Urgent with potential levee integrity issues due to the disturbance of the WS without prior approval from the CVFPB. (DWR UCIP - omagana)

04/28/2016 Landowner appears to have removed the WS headwall and pipe to make room for planting more orchard trees. LS pipe end was full of water as it has no where to drain to anymore. Changing to urgent listing but it currently does not affect the levee integrity. (see photos 8, 9, & 10) (DWR Sutter Yard - afreitag)07/14/2015 Crossing appears in good condition. No noticeable issues to report. (DWR Sutter Yard - afreitag)05/21/2014 Same as last inspection. (DWR Sutter Yard - afreitag)12/02/2013 Pipe section was dug up and repaired. Crossing is now in good condition. (DWR Sutter Yard - afreitag) 04/17/2012 Pipe collapse on WS 10 feet from toe, needs repair. From WS, sediment is visible inside pipe. (DWR UCIP - omagana)  
FIELD\_STRUCT\_DESC: 36-inch corrugated metal drainage pipe through the levee, 7.8 feet below the crown. Concrete "U" headwalls on both waterside (WS) and landside (LS) ends. Slide gate in corrugated metal pipe (CMP) riser on the WS slope. [Additional Reference(s): DWR Levee Log, 1993 (HLM 1.61), listed as 26-inch pipe. USACE

Overview of levee crown at crossing looking downstream.

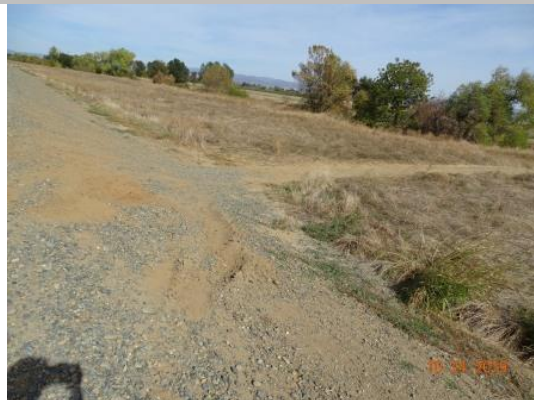
Photo 1 of 1 : SP\_2020\_MA0013\_300\_73\_20200226\_00011.jpg

LM Start	2.50	Rating **	M	Issue No.	73
LM End	2.50	Issue Type +	Ma	Location *	WS
Category	Earthen Levee			GPS Latitude/Longitude	
				Start	End
Item	Slope Stability			39.563676 °	39.563676 °
				-121.703775 °	-121.703775 °
DWR ID	DWR_MA0013_01_f_2019_73				
Comment Code					
S3 : Repair the levee slope damaged by vehicle traffic and prevent access where possible.					
Inspector Comment

View of depressions in the waterside slope due to vehicle traffic. Fall 2019.

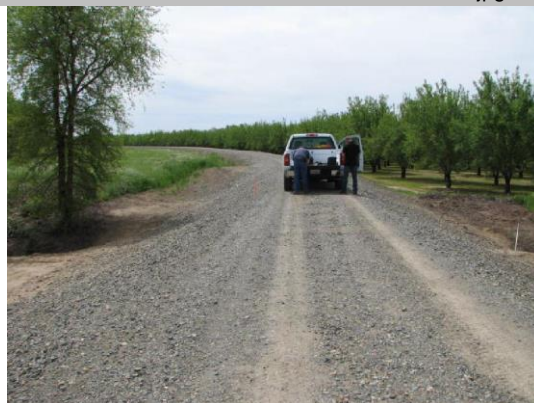
Photo 1 of 3 : UCIP\_SP\_2020\_54942\_66715.jpg

Comment Code						
Inspector Comment						
DS_ID:16347 FS_ID:54942 EP_NO: N/A Repair Type: Non-Urgent Crossing Status: Found UCIP Comments: 08/06/2019 Record has been updated from No Action Needed to Non-Urgent, no permit identified. Crossing is scheduled to be lined. (O. Magana - DWR UCIP, A. Freitag - DWR Sutter Yard)06/14/2017 Crossing appears to be in good condition. (DWR Sutter Yard- A.Freitag)11/16/2016 Crossing appears to be in good condition. (DWR Sutter Yard- A.Freitag)04/28/2016 Crossing appears to be in good condition.07/14/2015 Crossing appears in good condition. No noticeable issues to report.05/21/2014 Same as last inspection.12/02/2013 Same as last inspection.07/15/2013 Same as last inspection.04/17/2012 Vegetation/sedimentation from WS has been removed. This crossing was listed in the USACE Periodic Inspection report as Corp's inspect ID#USACE_CESPK_M13D_2011_p_0130 for WS flap gate closed and blocked by sediment. FIELD_STRUCT_DESC: 24-inch corrugated metal drainage pipe through the levee, 9.4 feet below the crown. Concrete "U" headwall on both waterside (WS) and landside (LS) ends. Flap gate on the WS end. [Additional Reference(s): DWR Levee Log, 1993 (HLM 2.74). USACE Sacramento O&M Manual 519, June 1962 (HLM 2.74), listed as 24-inch pipe] FS Date: 8/6/2019 9:39:00 AM

Overview of levee crown looking downstream at crossing.

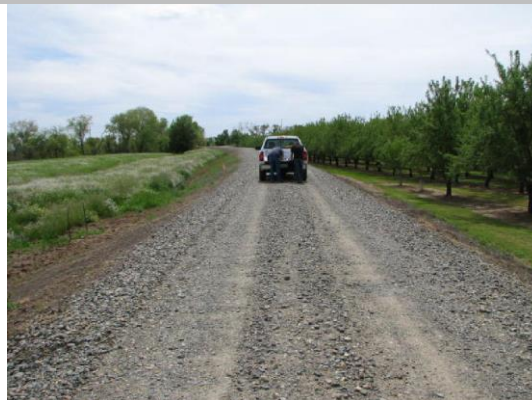
Photo 1 of 3 : UCIP\_SP\_2020\_54943\_66718.jpg

DS\_ID:17372  
FS\_ID:54943  
EP\_NO: N/A  
Repair Type: Non-Urgent  
Crossing Status: Found  
UCIP Comments: 08/06/2019 Record remains Non-Urgent, no permit identified authorizing pipe. Pipe has been internally cleaned and cleared of any obstructions on the WS and LS. DMP internal inspection pending. (O. Magana - DWR UCIP, A. Freitag - DWR Sutter Yard)06/14/2017 WS flap gate is completely buried by sediment-needs to be dug out. Pipe is about 50% full of sediment inside. Pipe has been selected to be internally cleaned and inspected as part of the DMP project. (DWR Sutter Yard- A.Freitag)11/16/2016 Pipe about 50% full of sediment. (DWR Sutter Yard- A.Freitag)04/28/2016 Pipe on LS is about 50% full of sediment. There is now a concrete pipe that discharges into the LS inlet of this crossing. Not sure where the concrete pipe comes from.07/14/2015 Crossing appears in good condition. No noticeable issues to report.05/21/2014 Same as last inspection.12/02/2013 Pipe section was dug up and repaired. Crossing is now in good condition.07/15/2013 Pipe appears to have a possible hole in top of pipe about 10ft. in from LS headwall.04/17/2012 LS headwall blocked by sediment (50 % of opening is covered). LS floor is higher than LS pipe invert. WS headwall has been recently cleared of vegetation and sediment. This crossing was listed in the USACE Periodic Inspection report as Corp's inspect ID#USACE\_CESPK\_M13D\_2011\_p\_0157 for WS and LS inlet/outlet blocked by sediment.

Overview of levee crown looking downstream at crossing.

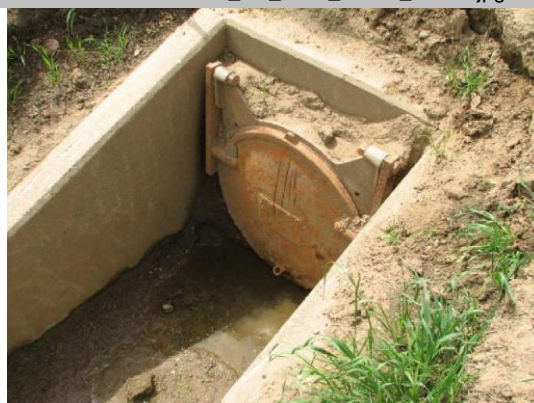
Photo 3 of 3 : UCIP\_SP\_2020\_54943\_66720.jpg

Flap gate on waterside.

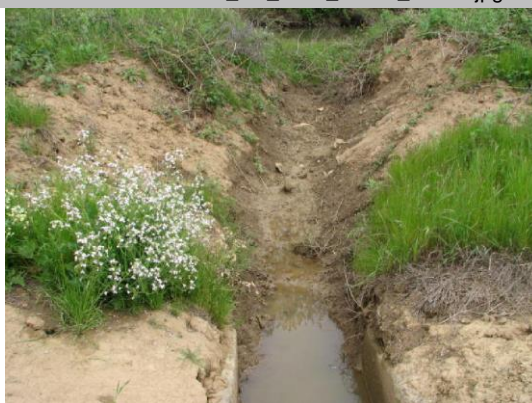
Photo 3 of 3 : UCIP\_SP\_2020\_54944\_66726.jpg

DS\_ID:16349  
FS\_ID:54944  
EP\_NO: N/A  
Repair Type: Non-Urgent  
Crossing Status: Found  
UCIP Comments: 08/06/2019 Record remains Non-Urgent, no permit found authorizing pipe. Pipe has been lined. (O. Magana - DWR UCIP, A. Freitag - DWR Sutter Yard)06/14/2017 Both pipe ends and gates are mostly buried- need to be dug out. Pipe has been selected to be internally cleaned and inspected as part of the DMP project. (DWR Sutter Yard- AFreitag)11/16/2016 Both gates closed but partially buried and unable to open. (DWR Sutter Yard- AFreitag)04/28/2016 Sediment build up on both gates blocking them from operating properly.07/14/2015 Crossing appears in good condition. No noticeable issues to report.05/21/2014 Same as last inspection.12/02/2013 Same as last inspection.07/15/2013 Stem on LS screw gate has been replaced and is now full functional.04/17/2012 LS slide gate stem is bent and prevents gate from fully closing. Both WS and LS have been cleared of debris and sediment. This crossing was listed in the USACE Periodic Inspection report as Corp's inspect ID#USACE\_CESPK\_M13D\_2011\_p\_0162 for inoperable gates on WS & LS due to sediment and grass blocking inlet and outlet.

Recent sediment removal on WS.

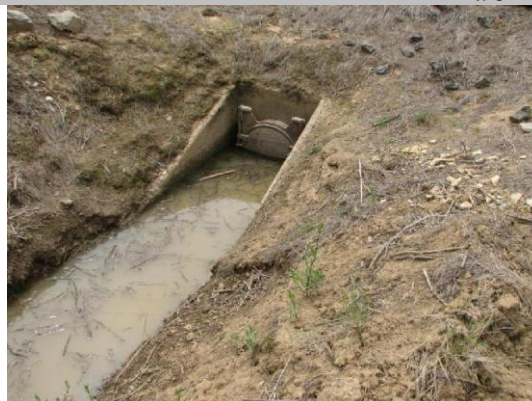
Photo 2 of 3 : UCIP\_SP\_2020\_54945\_66730.jpg

DS\_ID:16350  
FS\_ID:54945  
EP\_NO: N/A  
Repair Type: Non-Urgent  
Crossing Status: Found  
UCIP Comments: 08/06/2019 Record has been updated from No Action Needed to Non-Urgent, no permit has been found authorizing pipe. Pipe has been lined. (O. Magana - DWR UCIP, A. Freitag - DWR Sutter Yard)06/14/2017 WS flap gate is buried by sediment- needs to be dug out. Pipe has been selected to be internally cleaned and inspected as part of the DMP project. (DWR Sutter Yard- A.Freitag)11/16/2016 Crossing appears to be in good condition. (DWR Sutter Yard- A.Freitag)04/28/2016 Crossing appears to be in good condition.07/14/2015 Crossing appears in good condition. No noticeable issues to report.05/21/2014 Same as last inspection.12/02/2013 Same as last inspection.07/15/2013 Same as last inspection.04/17/2012 WS headwall has been cleared of debris and sedimentation.  
FIELD\_STRUCT\_DESC: 24-inch corrugated metal drainage pipe through the levee, 8.4 feet below the crown. Concrete "U" headwalls on both the waterside (WS) and landside (LS) ends. Flap gate on the WS end. [Additional Reference(s): DWR Levee Log, 1993 (HLM 3.31). USACE Sacramento O&M Manual 519, June 1962 (HLM 3.31), listed as 24-inch pipe]

View of WS flap gate.

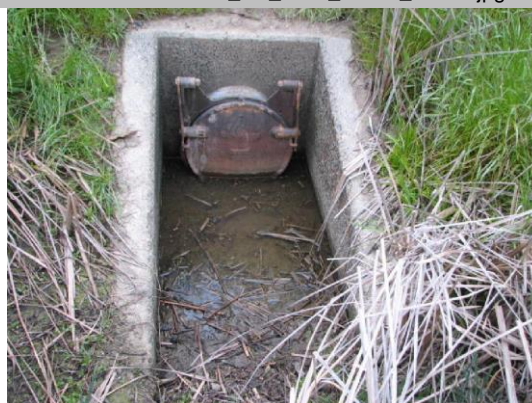
Photo 3 of 3 : UCIP\_SP\_2020\_54946\_66735.jpg

DS\_ID:16351  
 FS\_ID:54946  
 EP\_NO: N/A  
 Repair Type: Non-Urgent  
 Crossing Status: Found  
 UCIP Comments: 08/26/2019 Record has been updated from No Action Needed to Non-Urgent, no permit has been identified for this crossing. Crossing is scheduled to be lined. (O. Magana - DWR UCIP, A. Freitag - DWR Sutter Yard)06/14/2017 Both pipe ends were underwater during site visit. Pipe has been selected to be internally cleaned and inspected as part of the DMP project. (DWR Sutter Yard- A Freitag)11/16/2016 Crossing appears to be in good condition. (DWR Sutter Yard- A Freitag)04/28/2016 Both sides of the crossing were underwater during time of inspection.07/14/2015 Crossing appears in good condition. No noticeable issues to report.05/21/2014 Same as last inspection.12/02/2013 Same as last inspection.07/15/2013 Slopes have been cleared of vegetation and are in good condition.04/18/2012 Limited inspection on WS and LS slope due to dense vegetation. Need photos of cleared slopes.

WS flap gate

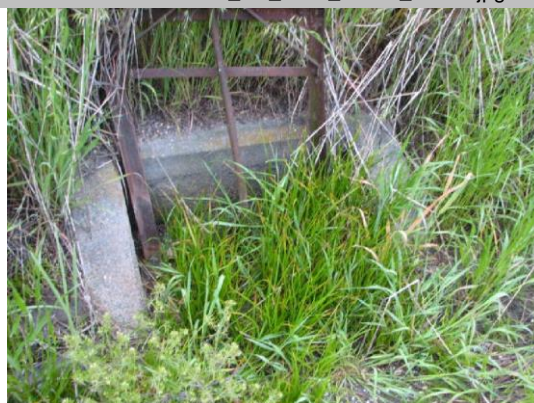
Photo 3 of 3 : UCIP\_SP\_2020\_54947\_66742.jpg

Comment Code					
Inspector Comment					
DS_ID:16365 FS_ID:54947 EP_NO: N/A Repair Type: Non-Urgent Crossing Status: Found UCIP Comments: 08/26/2019 Record remains Non-Urgent, pipe has been abandoned. No permit has been identified for this crossing. DMP internal inspection has not been completed. (O. Magana - DWR UCIP, A. Freitag - DWR Sutter Yard)06/14/2017 Appears abandoned-needs to be done properly. WS gate was buried/submerged and the LS slide gate is still damaged and buried. Pipe has been selected to be internally cleaned and inspected as part of the DMP project. (DWR Sutter Yard- A.Freitag)11/16/2016 Both LS and WS gates buried. (DWR Sutter Yard- A.Freitag)04/28/2016 Abandoned crossing. Ls screw is still bent and mostly buried.07/14/2015 LS screw gate is still damaged and buried. Crossing is non-functional.05/21/2014 Same as last inspection.12/02/2013 Same as last inspection.07/15/2013 Slopes have been cleared of vegetation and are in good condition. LS screw gate is still bent and silted over.04/18/2012 LS slide gate covered with silt. Slide gate is bent. Crossing appears not be in use. Limited inspection on WS and LS slope due to dense vegetation. Need photos of cleared slopes. FIELD_STRUCT_DESC: *ABANDONED* 24-inch corrugated metal drainage pipe through the levee, 7.9 feet below the crown. Flap gate on the waterside (WS) end. Screw gate on the landside (LS) end. Concrete "U" headwalls on both ends. [Additional Reference(s): DWR Levee Log, 1993 (HLM 3.80). USACE Sacramento O&M Manual 519, June 1962 (HLM 3.82), listed as 24-inch pipe] FS Date: 8/26/2019 12:24:00 PM

LS slide gate covered with silt. Slide gate is bent.

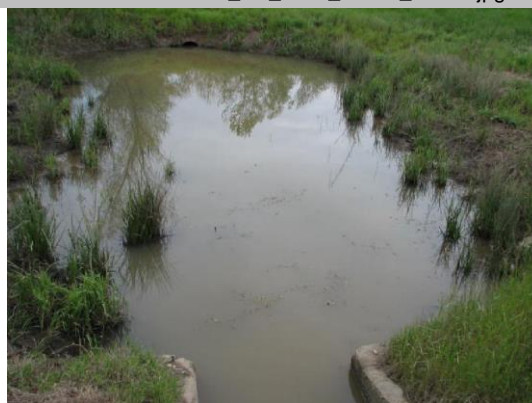
Photo 3 of 3 : UCIP\_SP\_2020\_54951\_66763.jpg

DS_ID:16356 FS_ID:54951 EP_NO: N/A Repair Type: Non-Urgent Crossing Status: Found UCIP Comments: 08/26/2019 Record has been updated from No Action Needed to Non-Urgent, no permit has been identified authorizing this pipe. Pipe is scheduled to be lined. Minor sloughing observed on LS just immediately d/s of concrete headwall (see photo). (O. Magana - DWR UCIP, A. Freitag - DWR Sutter Yard)06/14/2017 Crossing appears to be in good condition. Pipe has been selected to be internally cleaned and inspected as part of the DMP project. (DWR Sutter Yard- A Freitag)11/16/2016 Crossing appears to be in good condition. (DWR Sutter Yard- A Freitag)04/28/2016 Crossing appears to be in good condition.07/13/2015 LS screw gate was completely submerged and WS flap gate was propped open by a wood block but crossing appears to be in good condition.05/21/2014 Same as last inspection.12/02/2013 Same as last inspection.07/15/2013 Same as last inspection.04/18/2012 Minor vegetation on LS slope. This crossing was listed in the USACE Periodic Inspection report as Corp's inspect ID#USACE_CESPK_M13D_2011_p_0204 for restriction view of gates. FIELD_STRUCT_DESC: 24-inch corrugated metal drainage pipe through the levee, 8.4 feet below the crown. Flap gate on the waterside (WS) end. Slide gate on the landside (LS) end. Concrete "U" headwalls on both ends. [Additional Reference(s): DWR Levee Log, 1993 (HLM 5.43). USACE Sacramento O&M Manual 519, June 1962 (HLM 5.43), As-built DWG No. 50-4-3608, Sheet No. 3608/18, STA 839+50E, page 19 of 28 electronic file, listed as 24-inch CMP; As-built DWG No 50-4-3037 referenced not available] FS Date: 8/26/2019 12:29:00 PM

WS view of outlet cleared of vegetation.

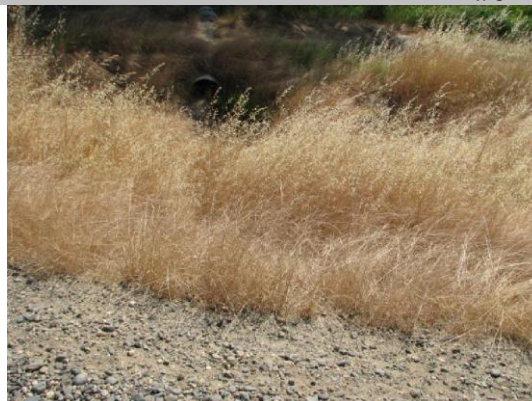
Photo 2 of 3 : UCIP\_SP\_2020\_54952\_66765.jpg

DS\_ID:16357  
FS\_ID:54952  
EP\_NO: N/A  
Repair Type: Non-Urgent  
Crossing Status: Found  
UCIP Comments: 08/26/2019 Record remains Non-Urgent, no permit has been identified authorizing this pipe. Pipe has been lined. (O. Magana - DWR UCIP, A. Freitag - DWR Sutter Yard)06/14/2017 WS flap gate is partially buried by sediment- needs to be dug out. LS appears to be in good condition. Pipe has been selected to be internally cleaned and inspected as part of the DMP project. (DWR Sutter Yard- AFreitag)11/16/2016 WS flap gate closed but blocked from opening by sediment. (DWR Sutter Yard- AFreitag)04/28/2016 WS flap gate blocked from opening by sediment.07/13/2015 WS flap gate is blocked from opening by sediment. Needs to be dug out.05/21/2014 Same as last inspection.12/02/2013 Same as last inspection.07/15/2013 Slopes have been cleared of vegetation and are in good condition.04/18/2012 Limited inspection on WS and LS slopes due to dense vegetation. Need photos of cleared slopes.

View of WS slope and channel.

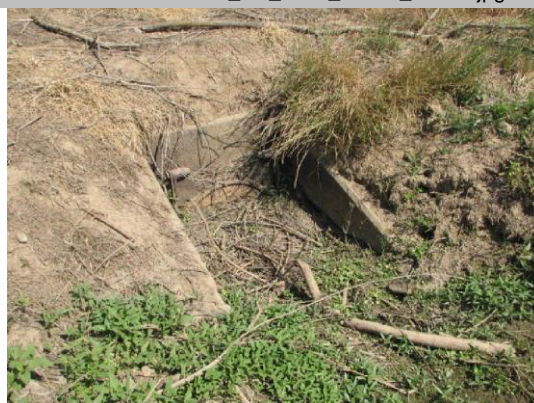
Photo 3 of 3 : UCIP\_SP\_2020\_54957\_66791.jpg

DS\_ID:16359  
FS\_ID:54957  
EP\_NO: N/A  
Repair Type: Non-Urgent  
Crossing Status: Found  
UCIP Comments: 08/26/2019 Record remains Non-Urgent, no permit has been identified authorizing pipe. Pipe is scheduled to be lined. (O. Magana - DWR UCIP, A. Freitag - DWR Sutter Yard)06/14/2017 WS Flap gate is completely buried- needs to be dug out. LS is blocked off by flashboards that are partially buried. Pipe has been selected to be internally cleaned and inspected as part of the DMP project. (DWR Sutter Yard- A.Freitag)11/16/2016 WS still completely buried. (DWR Sutter Yard- A.Freitag)04/28/2016 WS gate and headwall are buried. Only the top of the headwall was visible. LS appeared ok.07/13/2015 Both the LS screw gate and WS flap gate are completely buried.05/21/2014 Same as last inspection.12/02/2013 Same as last inspection.07/15/2013 Slopes have been cleared of vegetation and are in good condition. WS headwall and flap gate are fully covered in debris and not visible. Need to clear.04/18/2012 High sedimentation build up at WS and LS headwall. Limited inspection due to dense vegetation on WS and LS slope. Need photo of cleared WS and LS slopes. This crossing was listed in the USACE Periodic Inspection report as Corp's inspect ID#

View of WS flap gate buried.

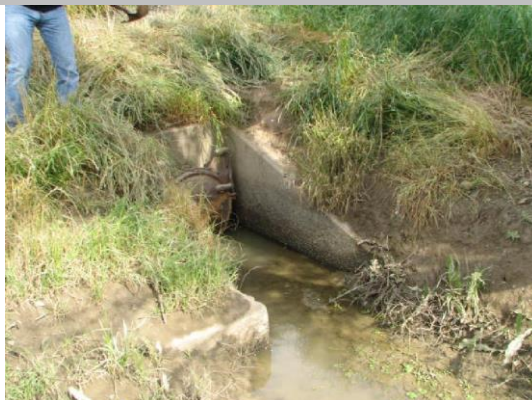
Photo 3 of 3 : UCIP\_SP\_2020\_54969\_66849.jpg

View of WS flap gate. Dense vegetation on WS slope.

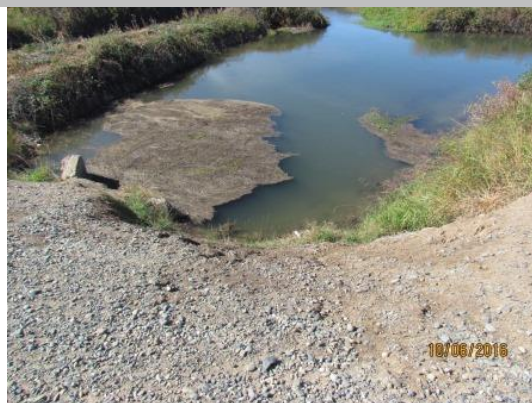
Photo 1 of 1 : SP\_2020\_MA0013\_300\_49\_20200226\_00007.jpg

View of the erosion site along the landside toe.

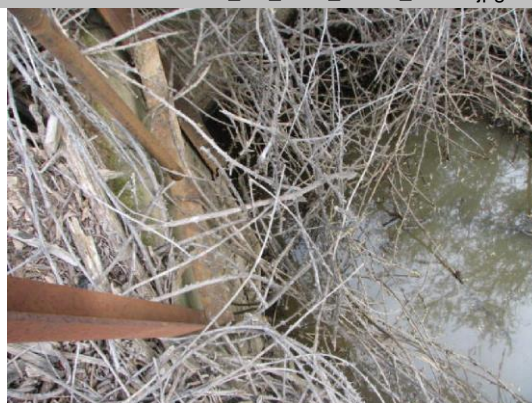
Photo 3 of 3 : UCIP\_SP\_2020\_54978\_66900.jpg

View of slide gate on WS. Debris blocking gate.

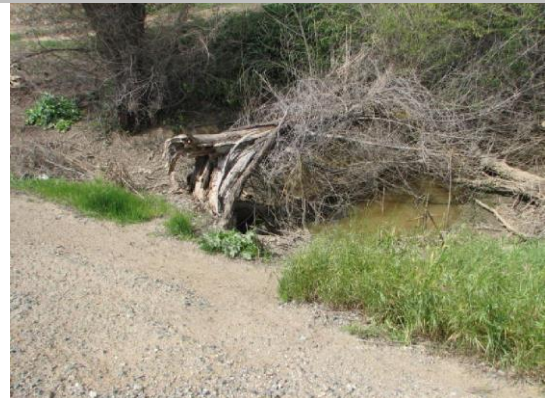
Photo 3 of 3 : UCIP\_SP\_2020\_54997\_66969.jpg

Tree fallen at LS headwall.

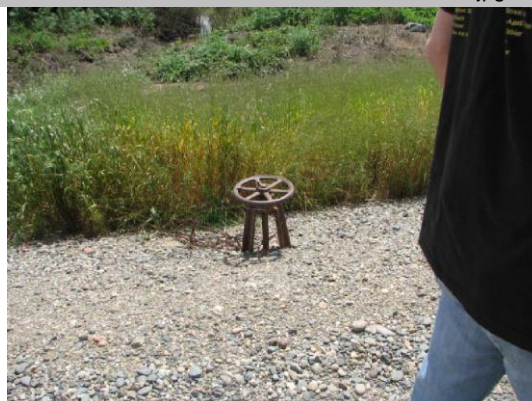
Photo 1 of 3 : UCIP\_SP\_2020\_54998\_66972.jpg

Buried slide gate on the WS slope.

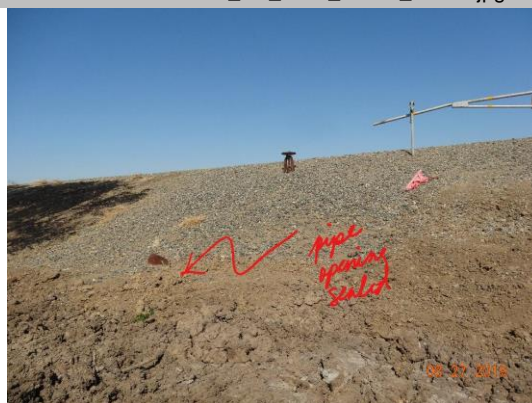
Photo 3 of 3 : UCIP\_SP\_2020\_54998\_80558.jpg

WS view: pipe section capped off on WS.

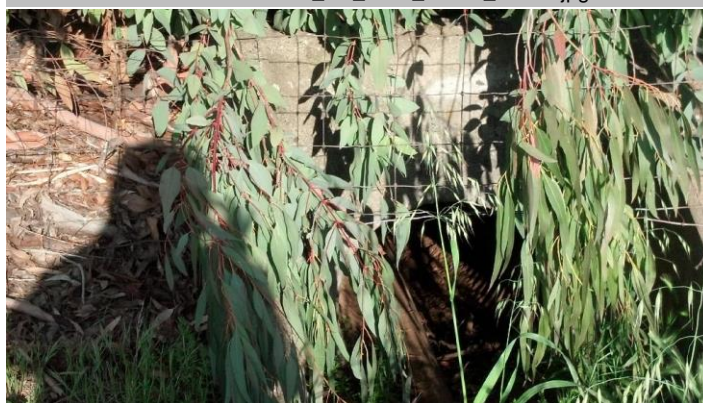
Photo 3 of 3 : UCIP\_SP\_2020\_55415\_45643.jpg

LS headwall blocked by overgrown branches.

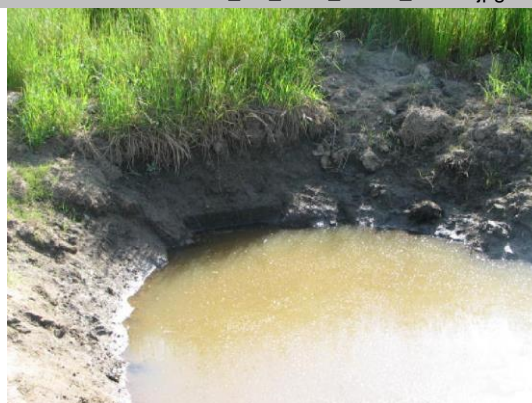
Photo 3 of 3 : UCIP\_SP\_2020\_55095\_67096.jpg

View of flap gate submerged on WS toe.

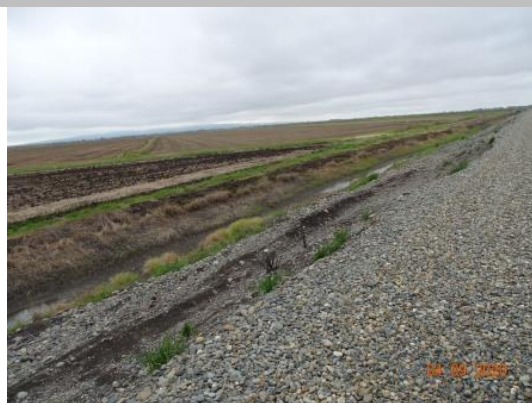
Photo 1 of 1 : SP\_2020\_MA0013\_301\_69\_20200415\_00179.jpg

View of slope instability along the landside slope. Spring 2020.

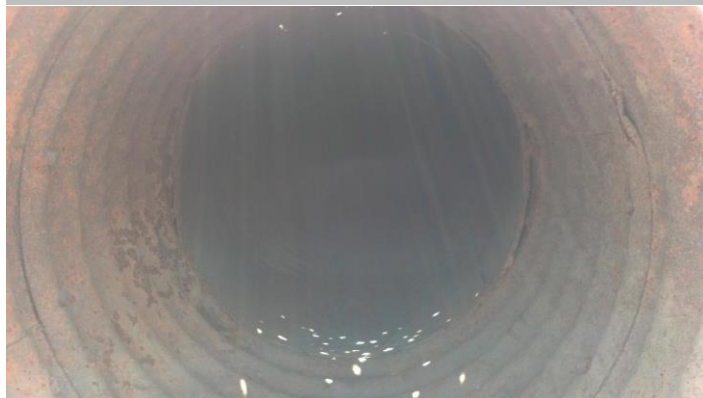
Photo 3 of 3 : UCIP\_SP\_2020\_55413\_67450.jpg

WS-view of internal pipe with severe corrosion-holes present along pipe wall.
